Informational Report of Investigation

Underground Coal Mine Explosion and Fire

INFORMATIONAL REPORT OF INVESTIGATION
UNDERGROUND COAL MINE EXPLOSION AND FIRE

Consol No. 9 Mine
Mountaineer Coal Company
Division of Consolidation Coal Company
Farmington, Marion County, West Virginia

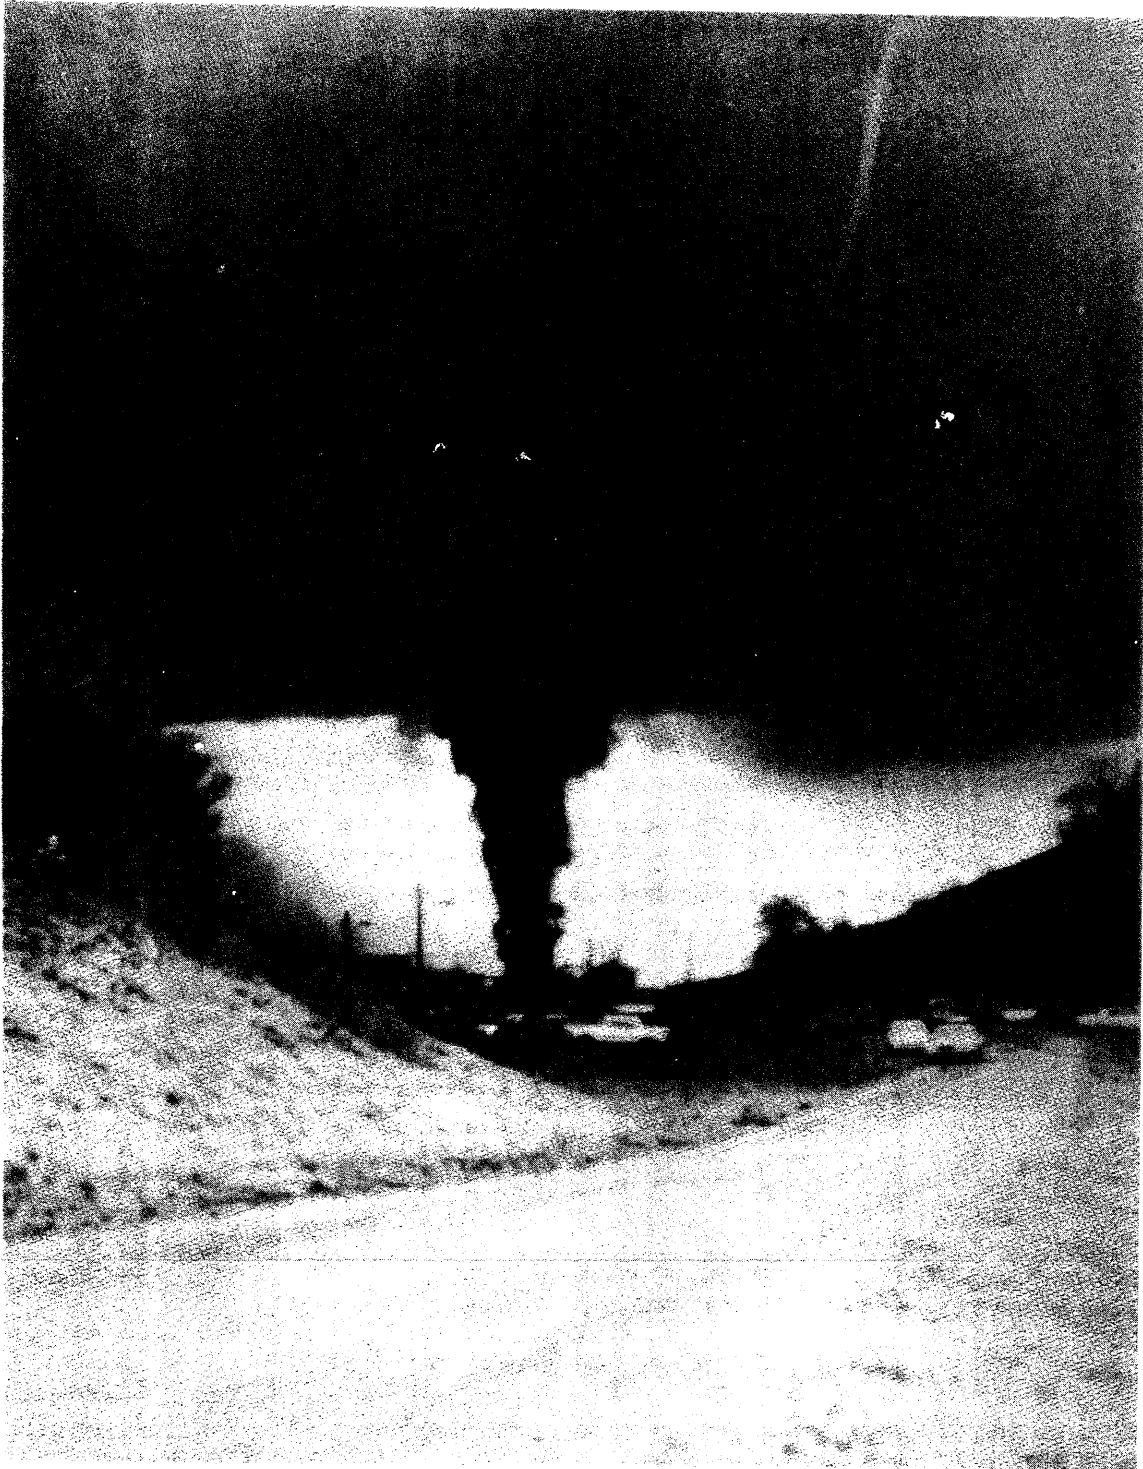
The forces of the explosion extended throughout the west side of the mine inby Plum Run overcast which included nine active working sections. Generally, the ventilating controls, such as stoppings, overcasts, and regulators inby the Plum Run overcast, were damaged or completely destroyed. The Nos. 3 and 4 fans (Mods Run and Llewellyn) ventilating the west side of the mine, the hoisting equipment in and above the Llewellyn Shaft, and part of the combination lamp house, bathhouse, and supply house located near the Llewellyn Shaft on the surface were also destroyed. (See Appendix E, Photo No. 1).

No. 1 Llewellyn Shaft after explosion

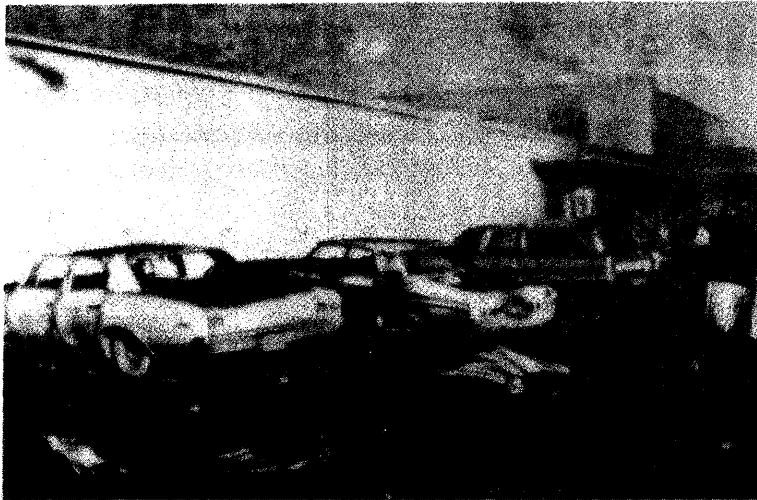
No. 5 Damage near Llewellyn Shaft

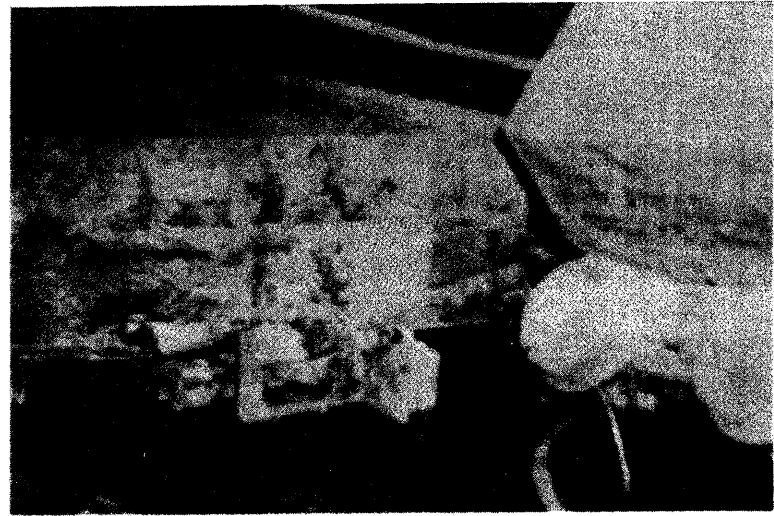
Exploration was stopped for several shifts while water was being pumped and roof falls were being leveled in the sealed area inby No. 92 crosscut. During exploration by a mine rescue team on October 23, the first body was found near a derailed 30-ton locomotive on the Main West haulage road at No. 98 crosscut. The second body was found at 11:20 p.m. the same day in the deck of a 30-ton locomotive at the No. 108 crosscut. (See Appendix E, Photo No. 17). After the fresh-air base had been advanced to the No. 106 crosscut, the bodies were recovered by the mine rescue teams and were later identified as Lester Willard and Charles T. Hardman, both locomotive operators. Hardman's wristwatch had stopped at 5:27. The empty trip of 31 mine cars with a locomotive on each end was known to have been traveling toward the west side of the mine when the explosion occurred. The empty cars were derailed and some were "jackknifed" by the forces of the explosion. An inspection of the lead (30-ton) locomotive by USBM electrical inspectors and Company personnel revealed that the locomotive controller was in the off position, the reverse lever was in the forward position, and the airbrake lever was about half applied. According to experienced Company personnel, this would compose a normal operating position of the front-end locomotive on this part of the haulage road. (See Appendix E, Photo Nos. 6, 8, 17, and 18).

No. 8 Wrecked mine cars inby 3 North

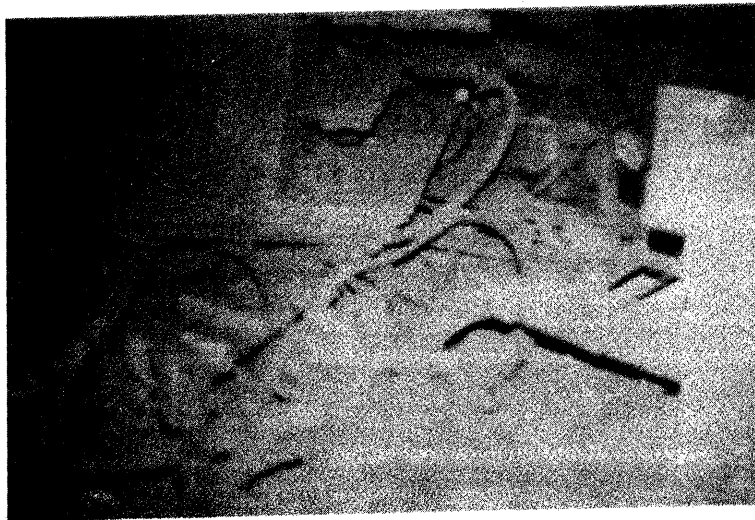
No. 9 Damaged power center 6 Right North

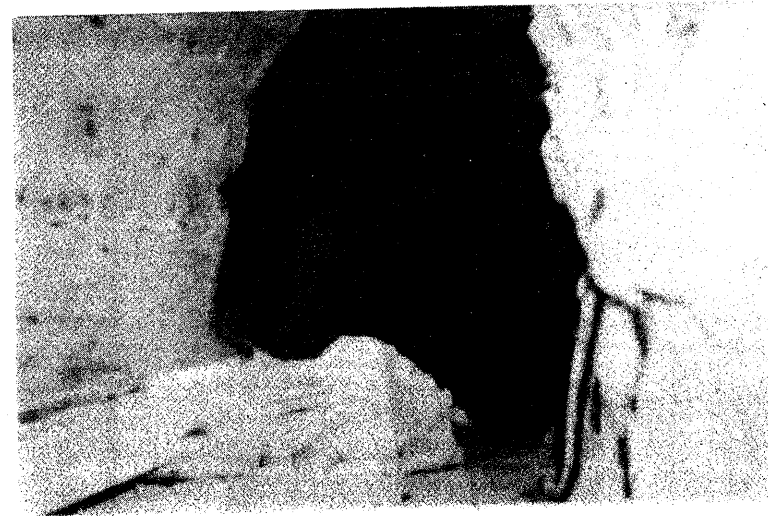
Extensive roof falls, as much as 30 feet in height, existed in all entries in most observable areas in the 1 Right 6 North section. (See Appendix E, Photo No. 10). In the open areas, soot streamers were present on the roof and heavy deposits of soot covered the mine floor, indicative of methane burning. Evidence of coke and soot were also present on the floor in the Nos. 2 and 4 entries between Nos. 11 and 14 crosscuts. (See Appendix I, Figure 5).

No. 10 1 Right 6 North after fall was loaded out

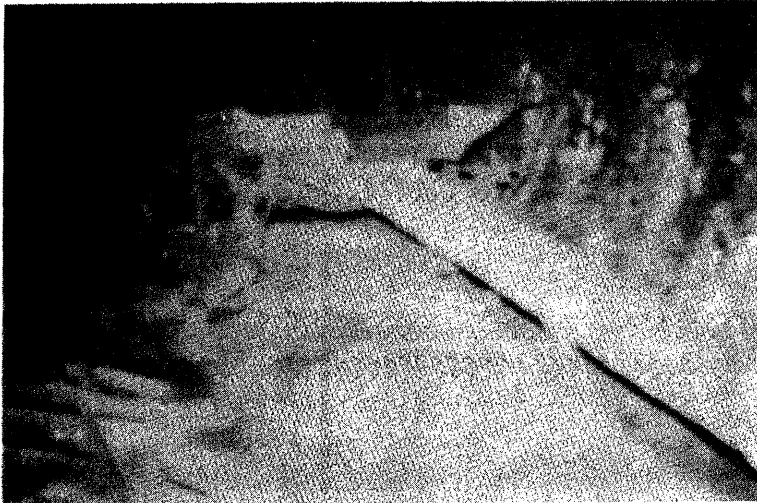
No. 13 Belt damage 1 Right 6 North

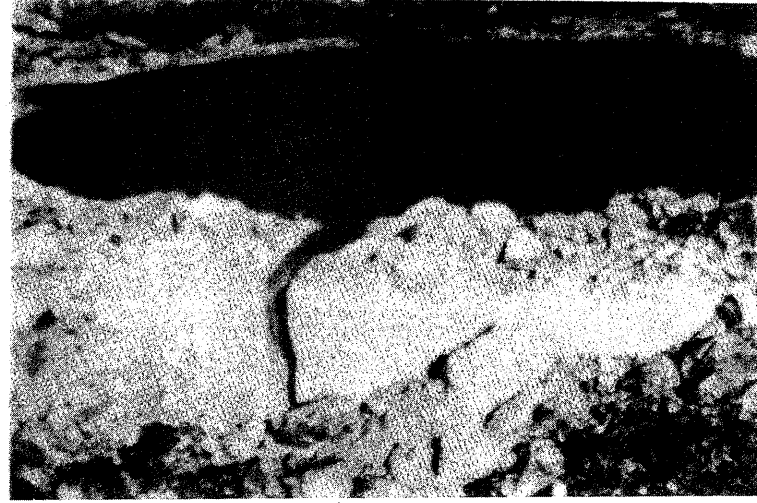
No. 14 Damage Mod's Run Intake Shaft

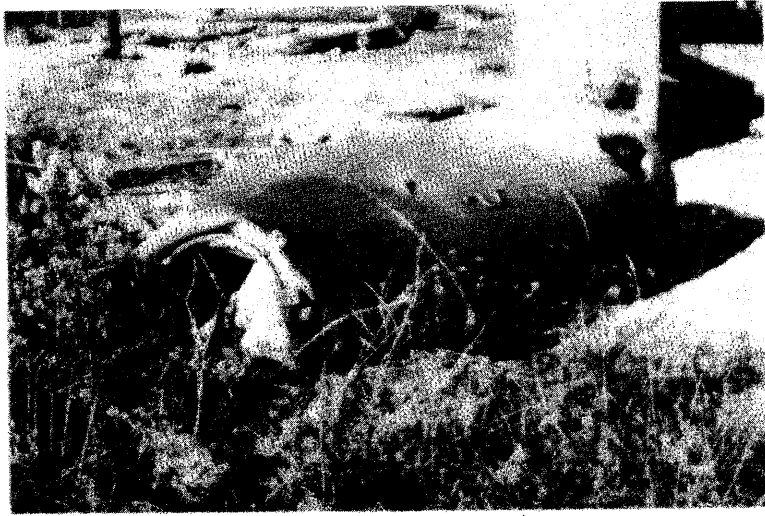
No. 15 Tank blown out of Mod's Run Intake Shaft

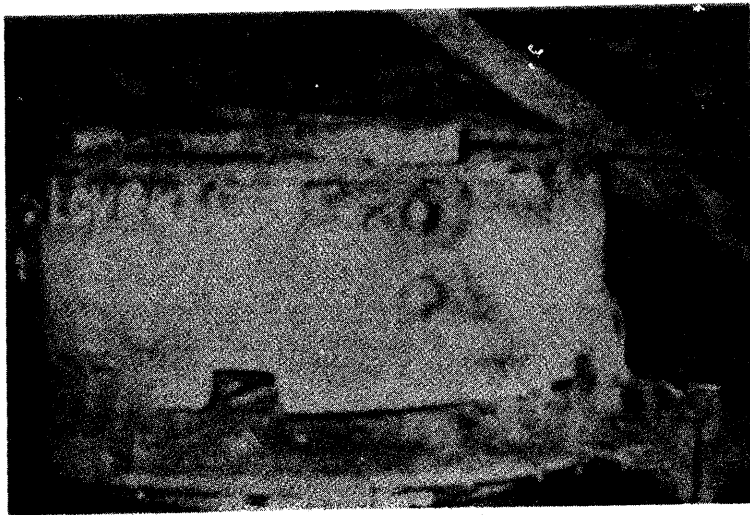
No. 17 Locomotive on inby end of trip of empty mine cars between 3 North and 4 North

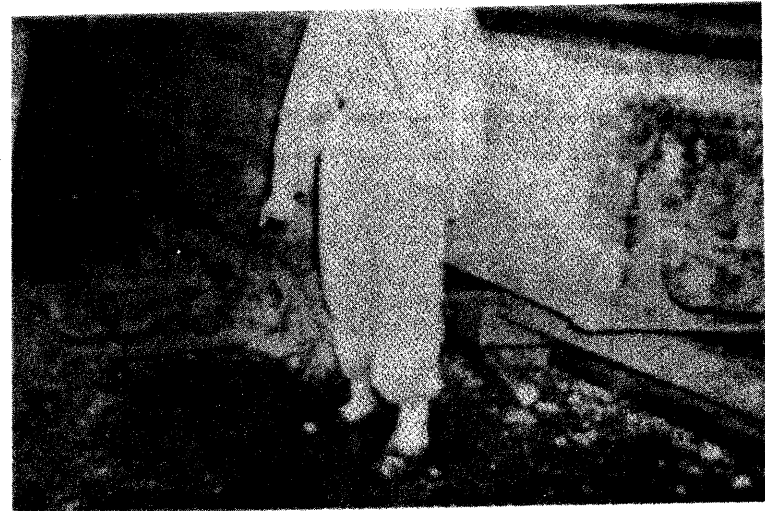
No. 18 Mine car blown from trucks between 3 North and 4 North

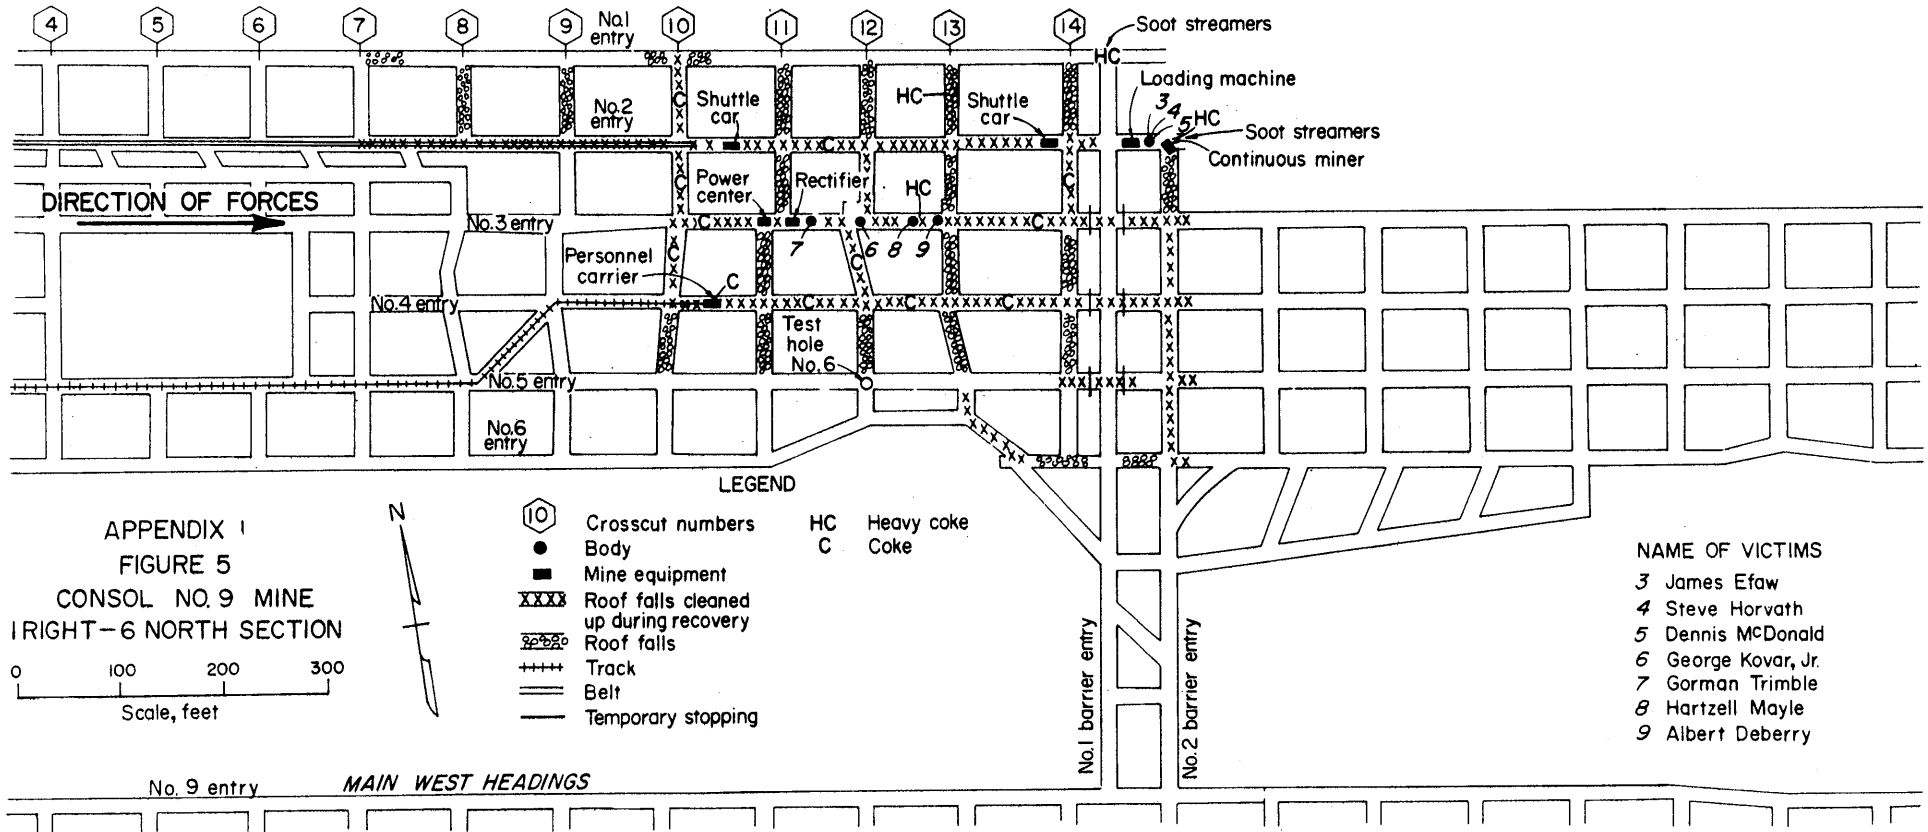
APPENDIX I
 FIGURE 5
 CONSOL NO. 9 MINE
 RIGHT-6 NORTH SECTION

The DC and AC power units found at the No. 11 crosscut in No. 4 entry were badly damaged by what appeared to be incoming forces of the explosion. Evidence of heavy coking was present on the floor in the No. 12 crosscut between the Nos. 3 and 4 entries and at many other areas throughout the section. The personnel carrier (jeep), recovered 45 feet inby crosscut No. 11 and in the No. 4 track entry, was damaged by the forces of the explosion; the drive motion and seat were blown off and the trolley pole was broken. Two shuttle cars were recovered while loading out the bottom layer of rock from the No. 2 entry between the belt tailpiece and the No. 14 crosscut. One shuttle car was located at the belt tailpiece, and the other one was located between the Nos. 13 and 14 crosscuts. Three of the rubber tires on the shuttle car were completely burned. The hydraulic hoses and the insulation on the trailing cables to both shuttle cars were also burned. (See Appendix I, Figure 5).
